VECTOR ROTARY LATCH - INLINE BOTTOM PULL

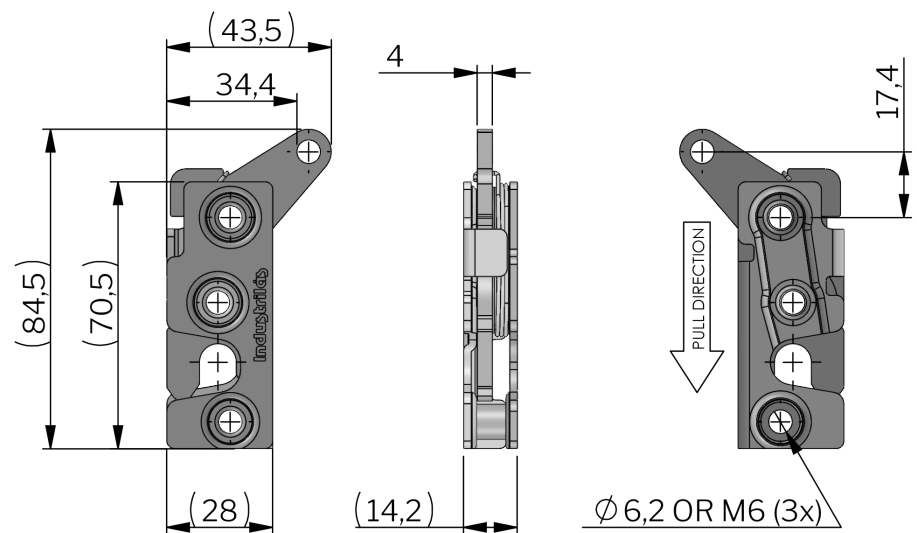
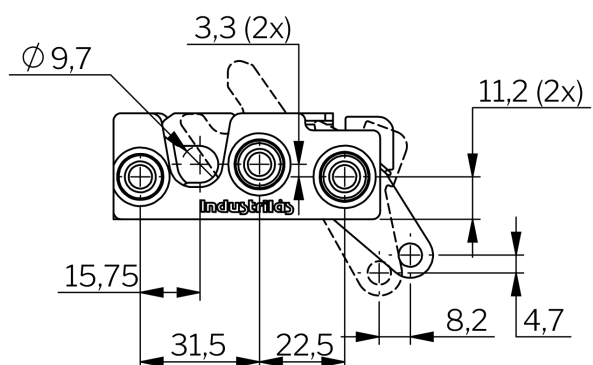
Vector rotary latches offer concealed latch points with convenient push-to-close action. Vector Rotaries are suitable for a variety of applications that require high strength, robust and secure latching. They are employed either as single latch point or in a multipoint latching system. Available in either single or two stage latching. The two stage rotary offers a safety feature that securely latches a partially latched compartment. Specially engineered to offer minimized trigger release force that ensures smooth and easy opening.

Vector rotaries are combined with Vector actuators that connect to the rotary latch by Vector rods or cables, creating an optimized latching system with components easily and securely fitted together. Please see related products to choose your components for your complete Vector rotary latching system.
